BOEING 757 INAPPROPRIATE CREW RESPONSE TO UNRELIABLE AIRSPEED CAUSES INJURIES AND DAMAGE

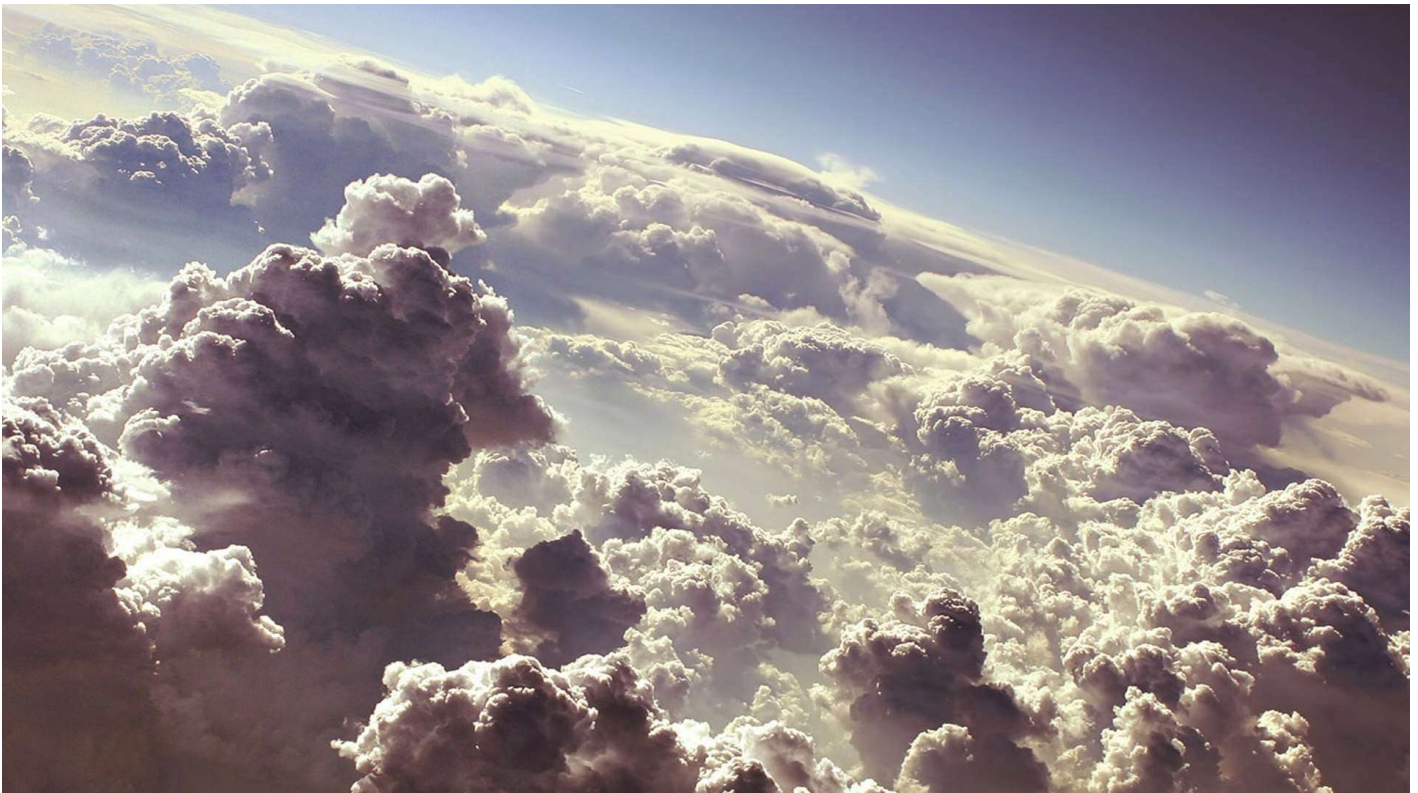
Damage to service bay and associated structure (AAIU)

The commander advised ATC that they had encountered severe turbulence and that medical assistance was required on arrival because some passengers had been injured. In addition, the Airport Fire Service was also requested to be in attendance on landing due to the loss of the centre hydraulic system. A normal landing was performed at Dublin, without further incident. On inspection it was found that the aircraft had sustained significant damage.
