AVIATRAFFIC B733 AT OSH ON NOV. 22, 2015, HARD LANDING COLLAPSES ALL GEAR

23 NOVEMBER 2015

SOURCE: THE AVIATION HERALD

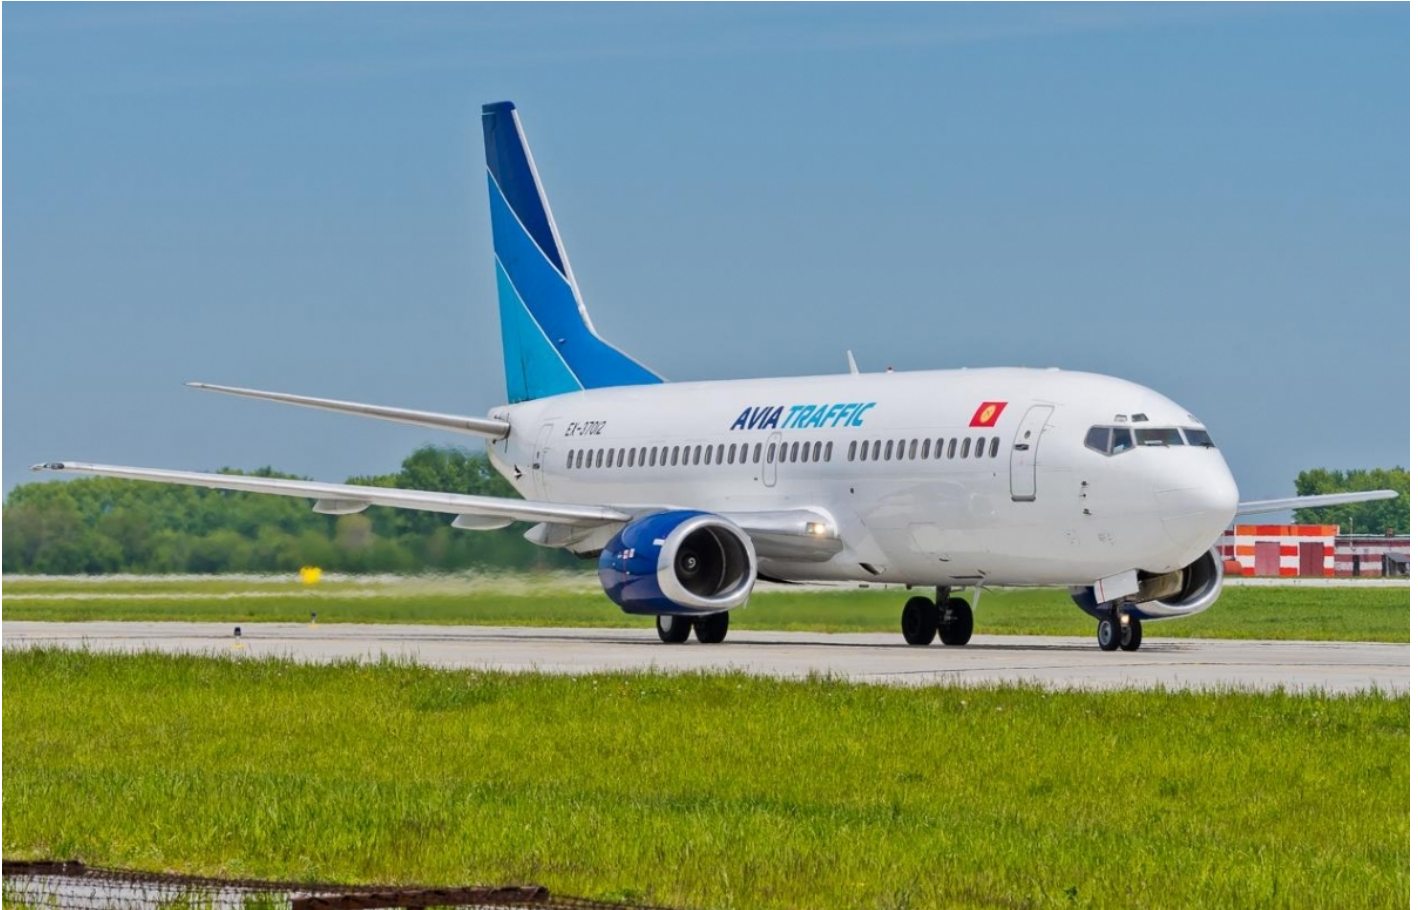
An Aviatraffic Company Kyrgyzstan Boeing 737-300, registration EX-37005 performing flight YK-768 from Bishkek (Kyrgyzstan) to Osh (Kyrgyzstan) with 153 passengers and 6 crew, performed an ILS approach to Osh's runway 12 at about 7:56 a.m. L (1:56 a.m. Z) but touched down hard causing all gear to collapse and separate, the aircraft went off the runway and ran over rough terrain, the left hand engine (CFM56) separated and the right hand engine received substantial damage before the aircraft came to a stop about 1500 meters down the runway. 3 occupants received serious, 5 occupants minor injuries. 6 injured were taken to hospitals, two refused treatment. The aircraft sustained substantial damage beyond economic repair.

Kyrgyzstan's Ministry of Transport stated the aircraft suffered a hard landing resulting in a runway excursion at 7:56 a.m. L. All gear collapsed, there were a number of injuries. The accident is being investigated.
