# CREW IRREGULARITIES REPORTED IN FATAL LEARJET CRASH

News / Business aviation

21 DECEMBER 2015

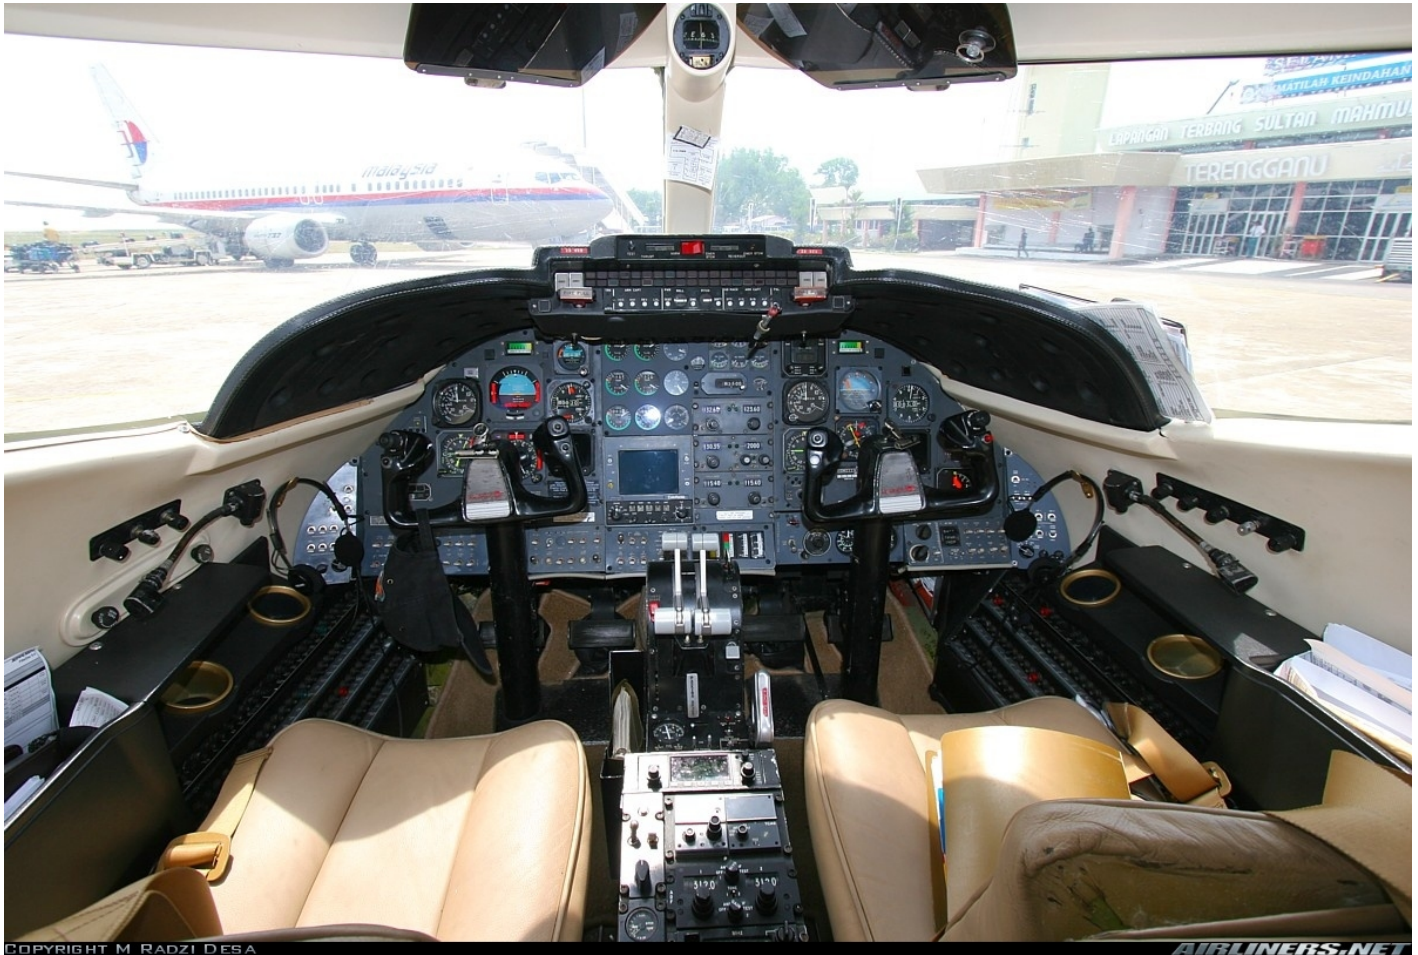
The NTSB discovered several irregularities and crew-performance failures in its investigation of the fatal crash of a Mexican-registered Learjet 35A on Nov. 19, 2013, according to the recently published factual report. Both pilots, a physician, and a flight nurse died when the aircraft plunged into the Atlantic Ocean following a loss of control during an emergency return after takeoff from Fort Lauderdale, Fla. The mission was a repositioning flight back to its base in Cozumel, Mexico. Night VMC prevailed and an IFR flight plan was filed.

Photographs of the submerged wreckage showed that the left engine’s thrust reverser was not in the stowed position. According to FDR information, about 100 seconds after takeoff, the left engine computer sensed a drop in engine speed. It continued to decline until the weight on wheels sensor transitioned from “in air” to “on ground,” possibly unlocking the reverser. But after about a 35-second decrease, engine speed values returned to normal. The FDR information showed that, except for that 35-second period for the left engine, the values recorded for each engine were similar.
