NTSB: PILOT RESPONDED INCORRECTLY TO ENGINE FAILURE IN WICHITA FSI CRASH

News / Business aviation

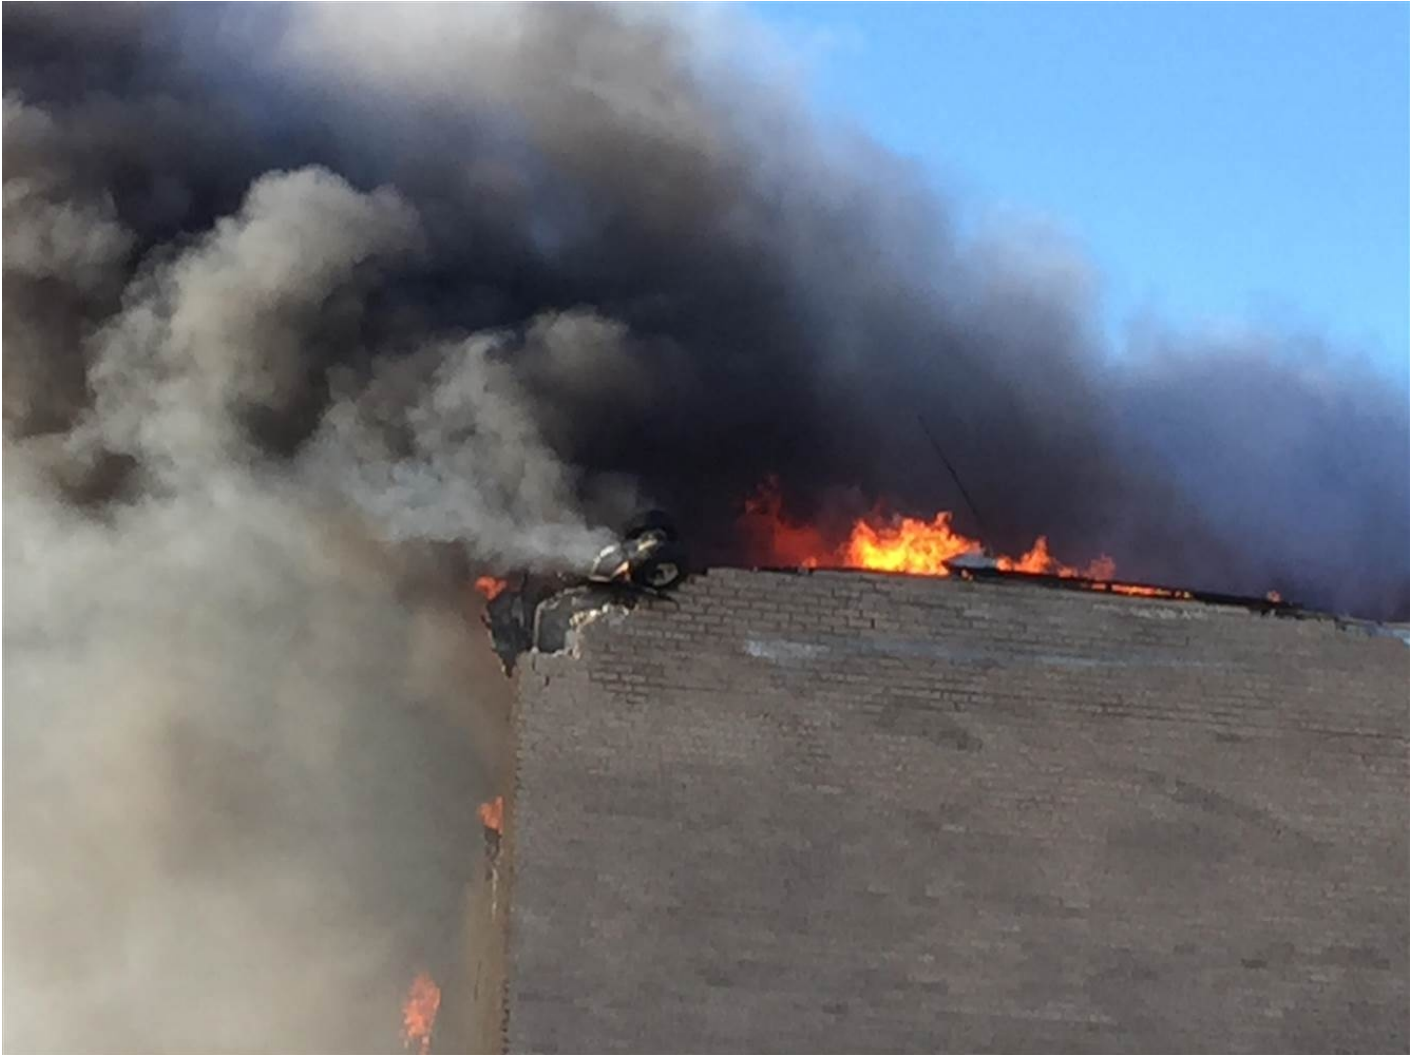
The pilot and sole occupant of a King Air 200 that crashed into a FlightSafety International (FSI) simulator building at Wichita Mid-Continent Airport (ICT) on Oct. 30, 2014 responded incorrectly to a decrease in power from the twin turboprop's left engine on takeoff, according to the NTSB's probable cause report.

Post-accident examination of the wreckage did not indicate any anomalies, with investigators noting that neither propeller was feathered before impact. Damage signatures indicated that both engines were operating before the accident, with analysis of propeller blade angles and sound spectrum analysis further revealing that the left engine “was likely producing low to moderate power and that the right engine was likely producing moderate to high power” on impact with the building.

Although most of the aircraft was destroyed in the crash, the NTSB determined that available evidence indicated the pilot failed to follow emergency procedures for an engine failure during takeoff, including landing-gear retraction and feathering the propeller on the affected engine.
