# CORROSION WARNING FOR BELL 429 OPERATORS

News / Manufacturer

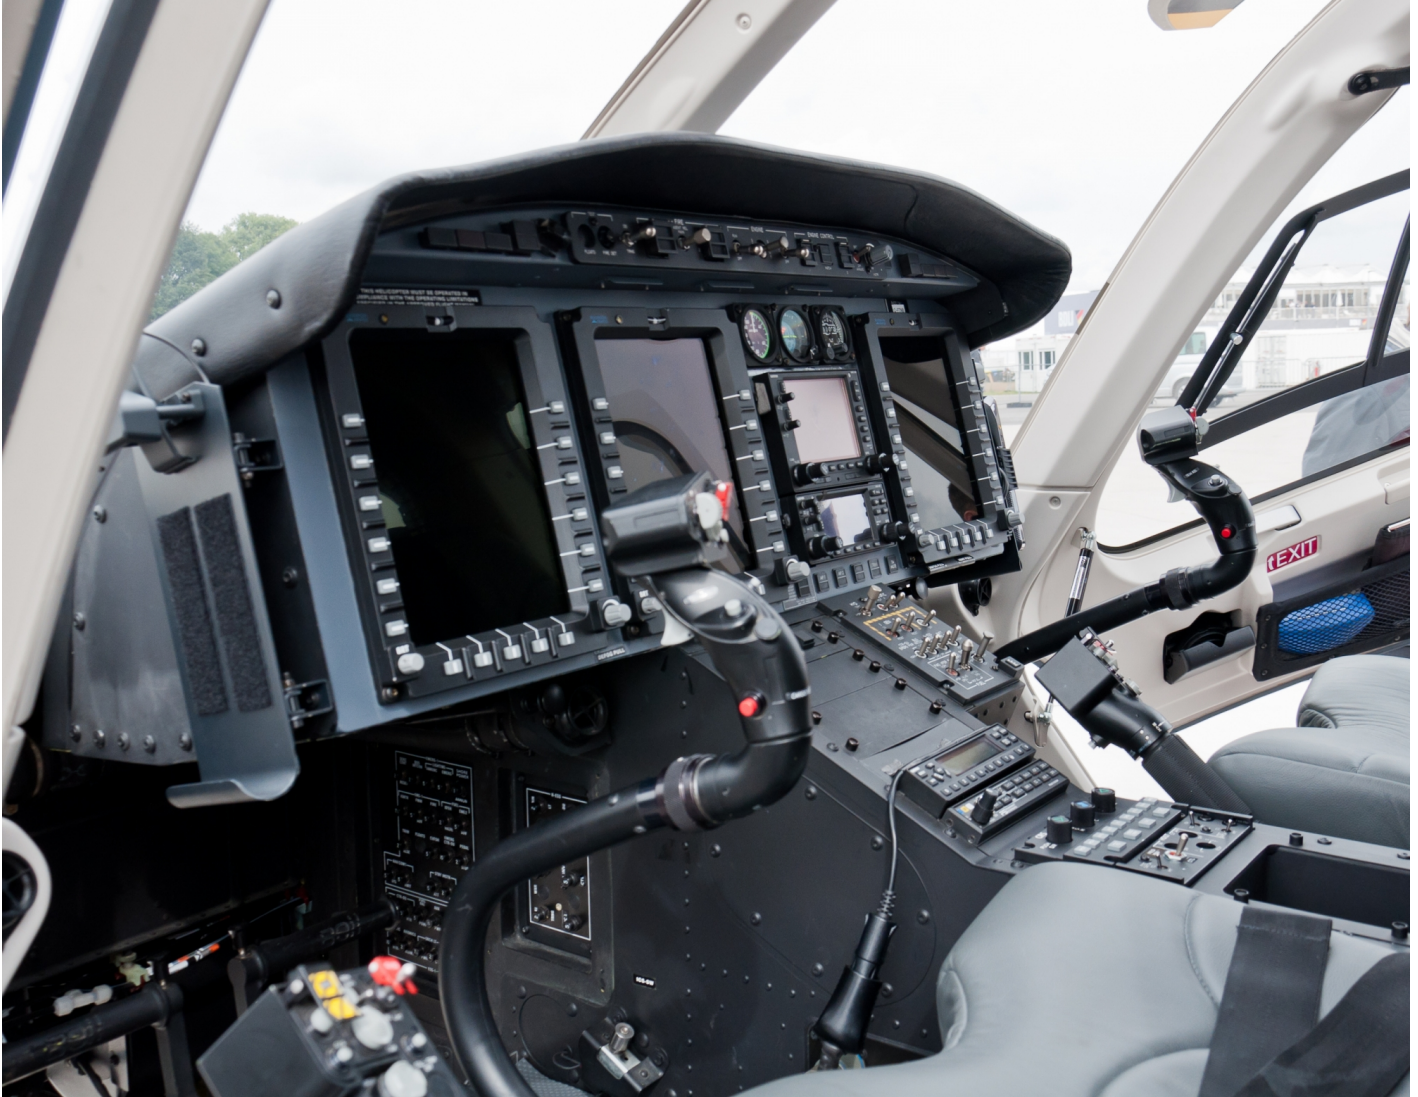
Its warning comes after an in-flight failure of a tail rotor pitch link on a 429. This caused “noticeable vibration” and “difficulty controlling the helicopter”, says Transport Canada.

A subsequent investigation revealed that the pitch link had fractured, with a crack originating at a corrosion pit.

“Further investigation revealed deficiencies in the application of corrosion resistant finishes to the pitch link during the manufacturing process,” Transport Canada says.

Operators are mandated to inspect affected pitch links for signs of corrosion and replace them as necessary.
